RESIDENTIAL HOUSE
3911 CANDLENUIT LN.
DALLAS, TEXAS 75150

HOUSE PLAN
SHEET A-1

FOUNDATION INSPECTION

RE: Foundation Inspection
3911 Candlenut Lane
Dallas, Texas 75244

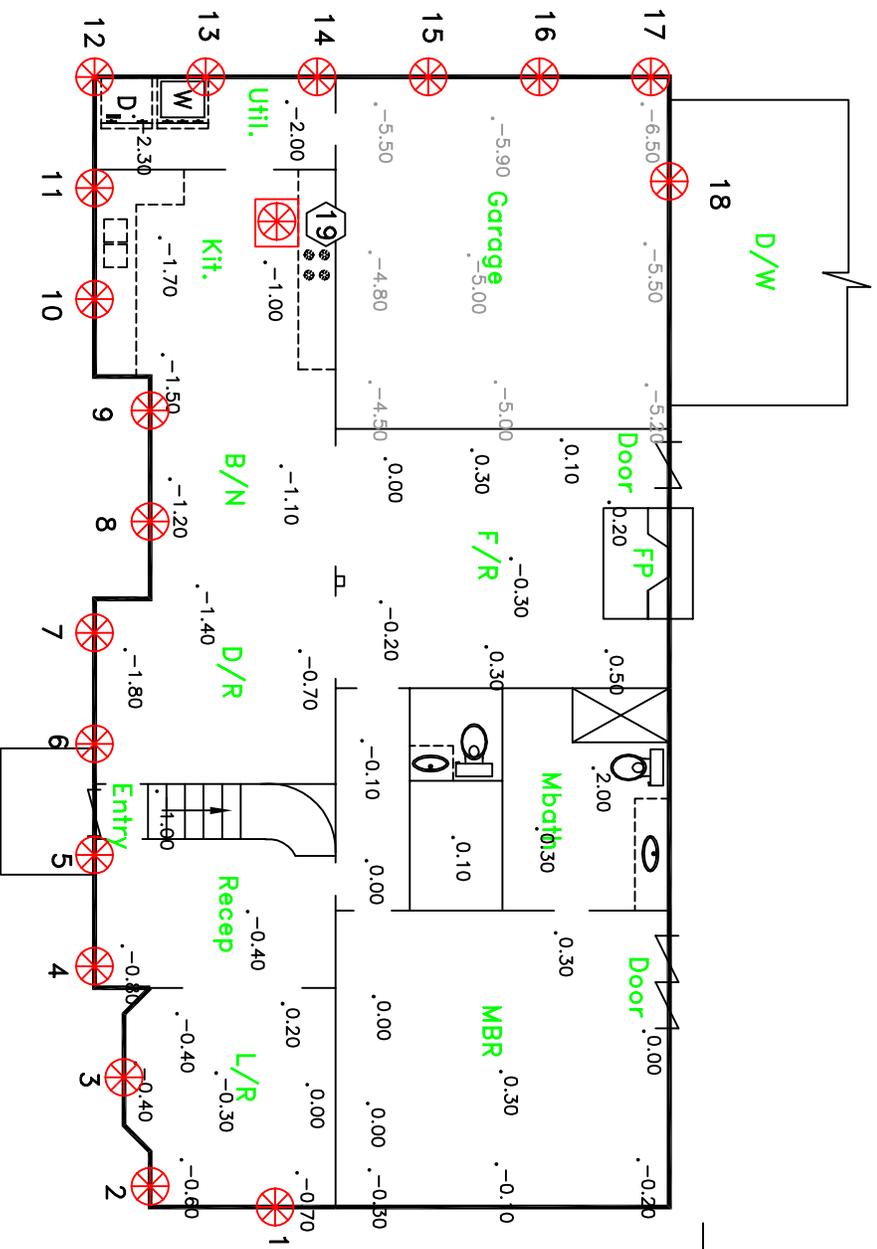
The attached repair diagram indicates that the house appears to have settled at the front left corner extending into the interior portions of the house causing the crack, noticed at this location. The left side of the house near the kitchen and garage are down as well. The amount of deflection is considered moderate for this type of structure and age of the house. Our inspection determined localized areas of deflection at the above listed areas.

1. INSTALL UP TO 18 EXTERIOR PERIMETER REPAIR PIERS PER ATTACHED DETAIL.
2. INSTALL UP TO TO 1 INTERIOR REPAIR PIERS, THE EXACT LOCATION WILL DEPEND ON THE STRUCTURAL CHARACTERISTICS OF THE FOUNDATION AND LOCATION OF INTERIOR BEAMS.
3. USE STEEL SHIMS FOR ALL FINAL VERTICAL ADJUSTMENTS.

It is recommended that the areas noted above should be stabilized with unpinning and to reduce the deflection of the foundation. The repair plan calls for a total of **19** concrete pressed piles/piers. This should adequately address the deficiencies discovered during our inspection and subsequent analysis of the foundation's condition. Without the recommended repairs, the areas referenced and noted cracks will remain open and prone to continued deterioration.
