**GREEN SCENE**  
HOME INSPECTIONS  
*Do the Right Thing, Always tell the Truth, Help Others*

**23 Carter Ct, Allen, TX 75002**

Prepared For: Richard Lee Barrett, Sr. Living Trust, August 3, 2024

# PROPERTY INSPECTION REPORT FORM

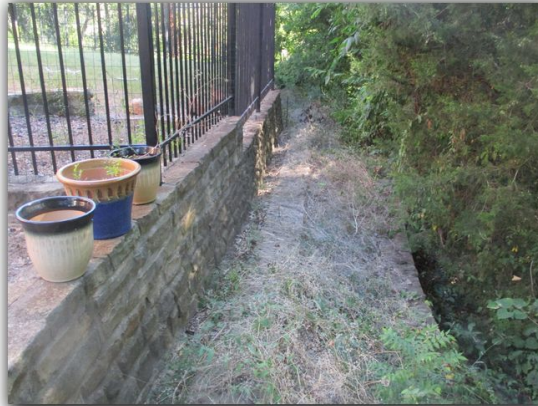
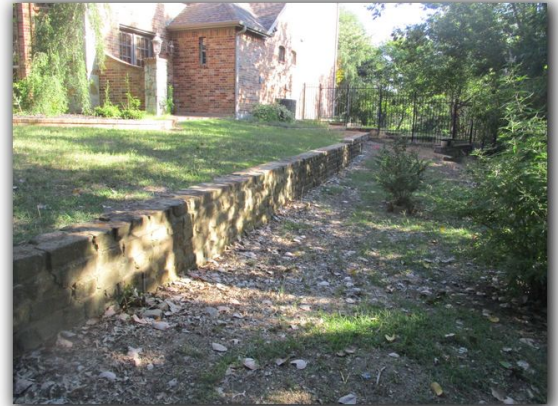
Inspection by Bryan Oglesby 0813734 in May of 2020 found termites in the area but noted no damage. Bait traps installed and maintained by Texas in 2020. No more evidence of Termites has been found in the 4 years ( May 20 - Dec 2024 )

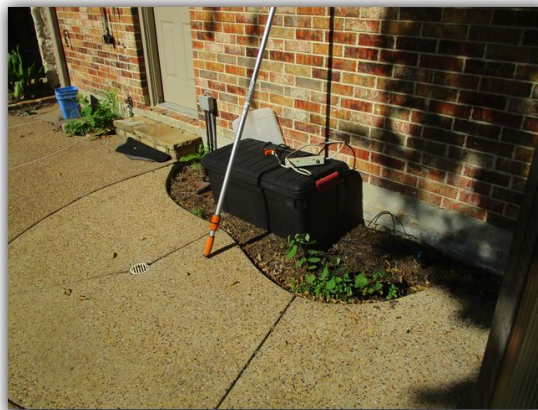
- Ground erosion was observed on the east side of the structure. Fill dirt is needed against the foundation perimeter wall where the soil line is too low to help support the foundation footer properly.
- Marginal site drainage was observed on the north side of the structure. Proper drainage is needed to help prevent water from standing and/or ponding next to the foundation beam. Corrective measures may be needed if the water stands within 10-feet of the foundation perimeter beam for more than 24-hours.

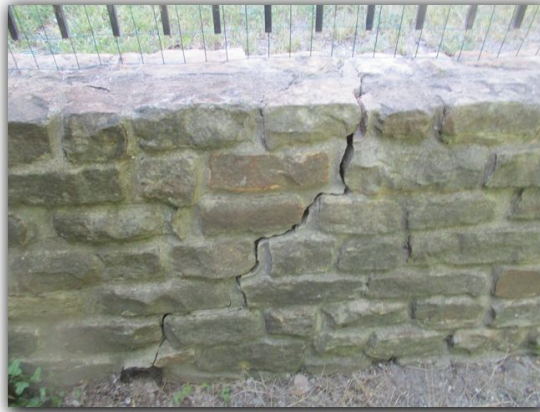
**Note:** There is cracking/spalling observed in the retaining wall in place on the east side of the structure.

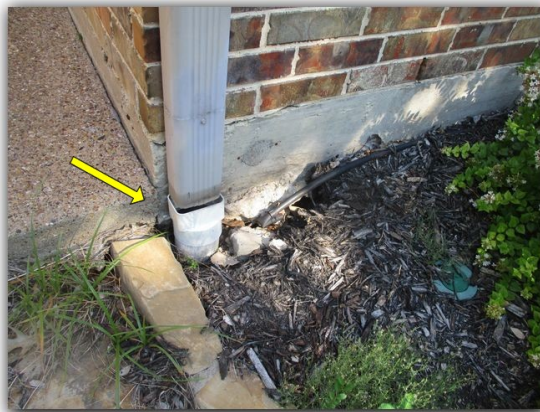
- The guttering system is draining to the roof on the north side of the structure.
- The gutters are dirty and are not functioning properly.
- The downspout is separated from the sub-surface draining system on the east side of the structure.

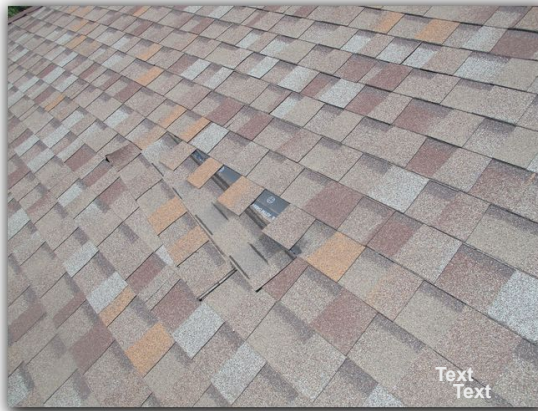
- Damaged shingles were observed on the east side of the roof structure.

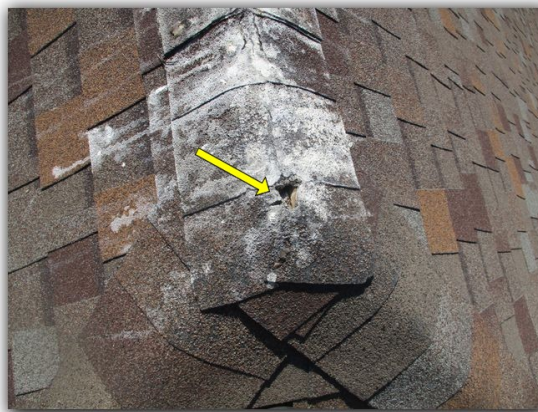
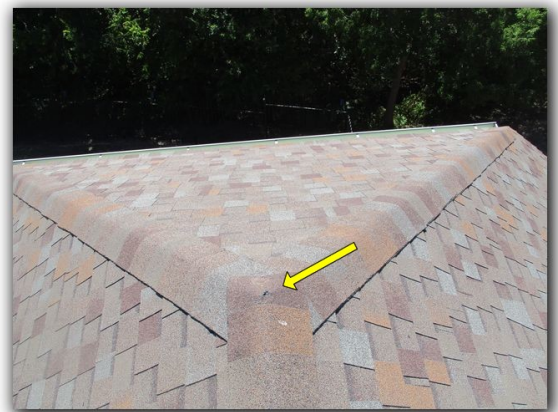
- Damaged drip edge shingles were observed on multiple sides of the roof structure.

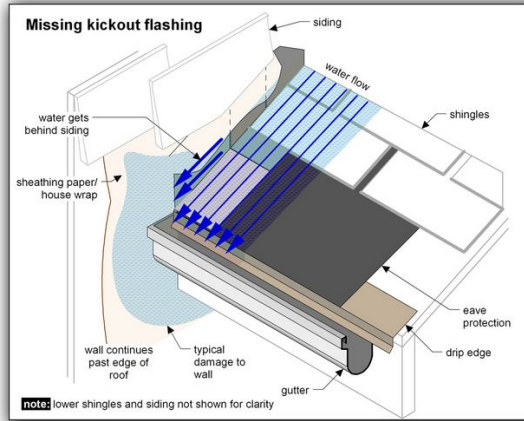
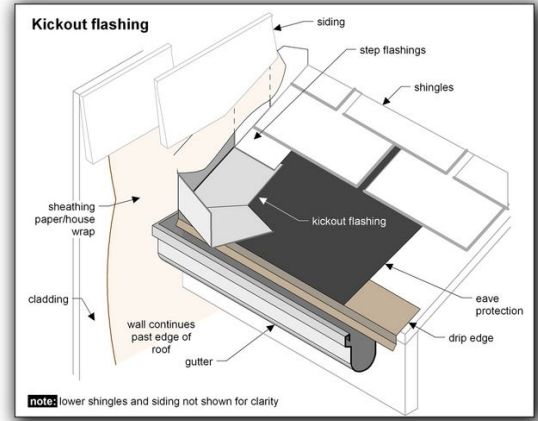
- There was no kickout flashing observed at the lower bottom edge of the roof line interface and the sidewall that continues past the edge of the roof. The lack of this kickout flashing will allow water to penetrate at these points.

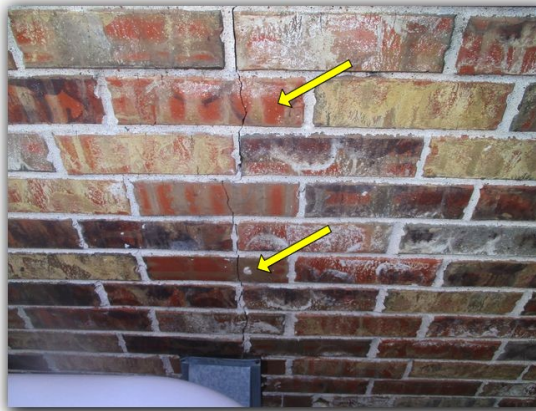
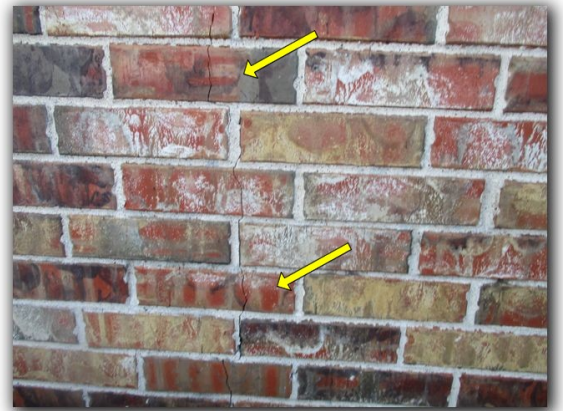
- Deflection cracks were observed in the exterior veneer on the north side of the structure.

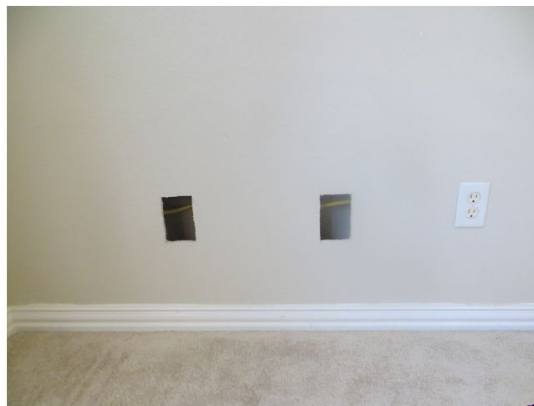
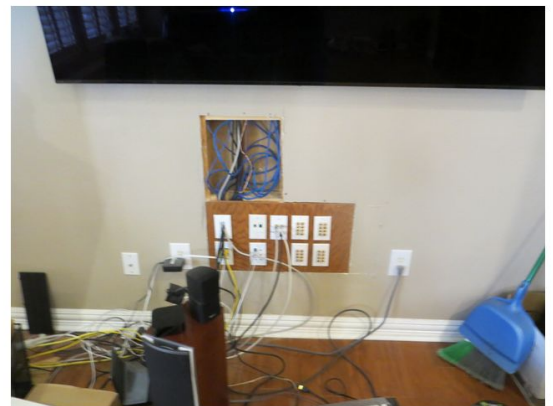
- There are holes/damage observed in the drywall in the upstairs guest bedroom, living room, garage and upstairs office

Dry wall repairs preformed by PREMIER PAINTING were preformed in 5 locations throughout the home. These were created for computer network cable upgrades and expanding electrical in the bathroom for a bidet

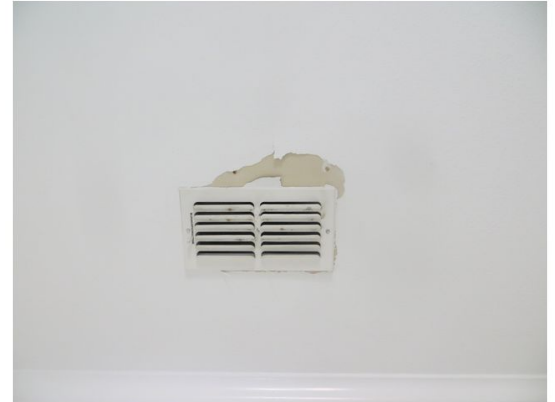
This was due insulation missing in the vent in the attic creating a temperature differential and associated condensation. This has been corrected and repaired by PREMIER PAINTING

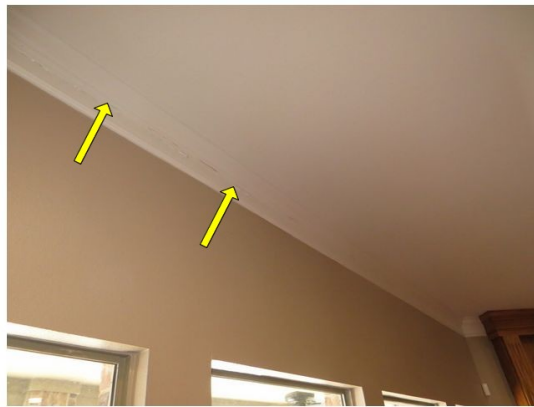
- Crown moulding separations were observed at the ceiling in the: living room. The cause and remedy should be further evaluated and corrected as necessary.

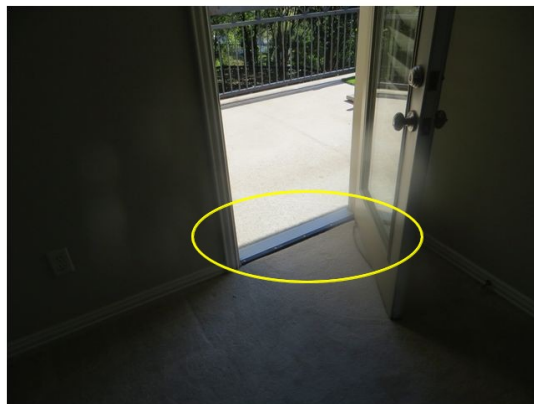
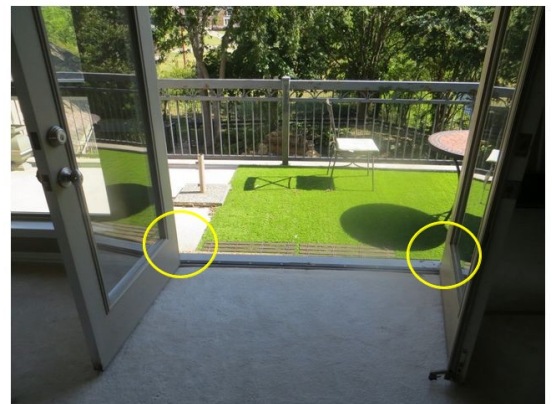
- Water damage and/or deterioration was observed in the wooden exterior balcony entry door(s). This can be a conducive condition for wood-destroying insect activity and/or wood rot.

Fix of the upstairs balcony door and associated 1st story kitchen leak was fixed by "your home expert" on Nov 11, 2024 project manager Vitaly

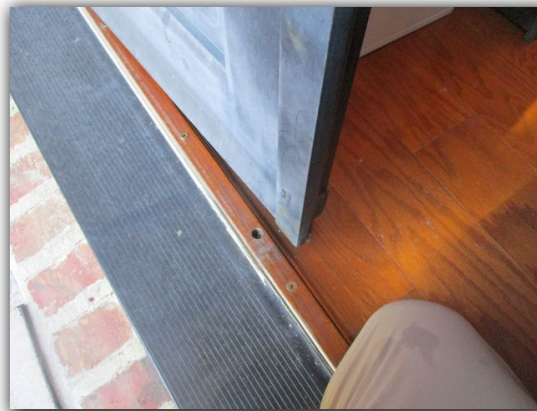
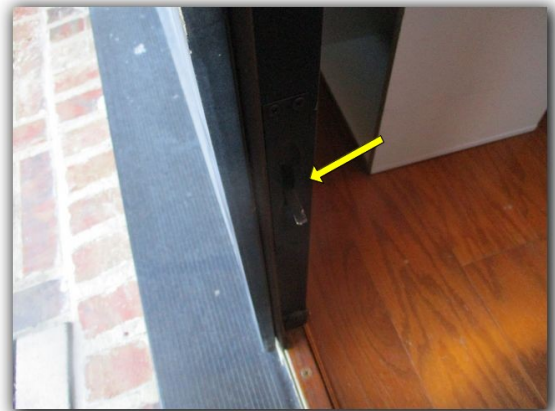
- The exterior doors were found to be aged and mostly functional. The exterior doors were found to show signs of rubbing, stiffness and/or difficulty operating, as well as degraded and general damage to the components. This is to be expected as part of the "wear-and-tear" of doors in a home of this age. Ongoing maintenance will need to be performed to assist the doors in their intended function. This will include but is not necessarily limited to: repair to the components, lubricating and weather stripping improvements, and regular adjustments and cleanings. The future life expectancy of the doors cannot be determined. You can continue to use and service these doors until replacement is necessary.
- The office door rubs when opened/closed.
- The front entry door hardware does not function properly.

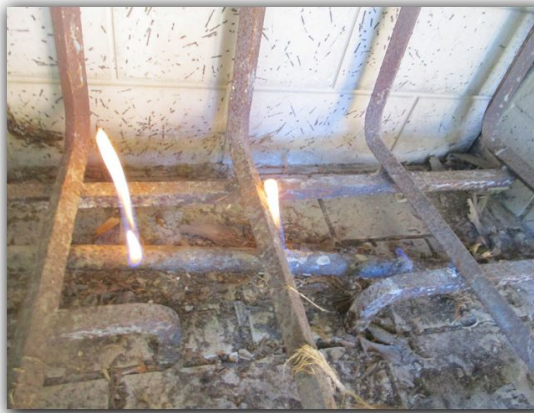
- The gas starter bar ports appear to be plugged and/or clogged.

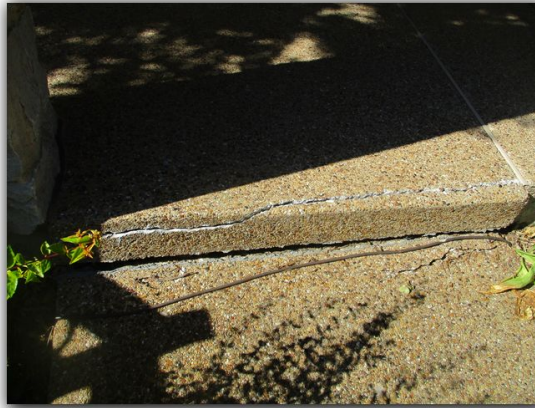
- Cracks and/or deficiencies were observed in the patio.

RC landscaping fixed sprinklers and the cracks on patio edges September 26th, 2024

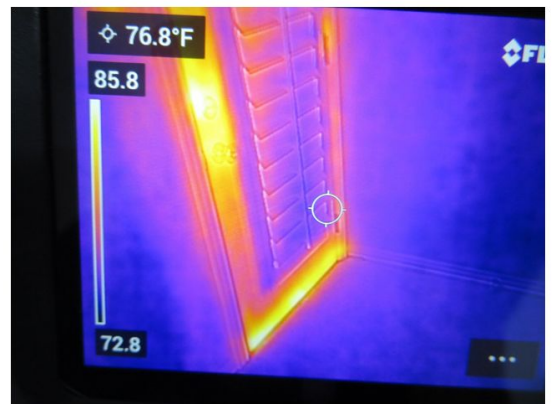
- There is evidence of possible previous water intrusion in one or more of the floors in the upstairs rear corner bedroom. Although all moisture content was within an acceptable level, this condition should be further evaluated and corrected as necessary.

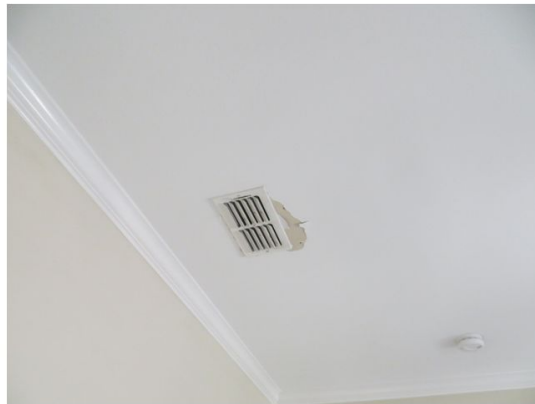
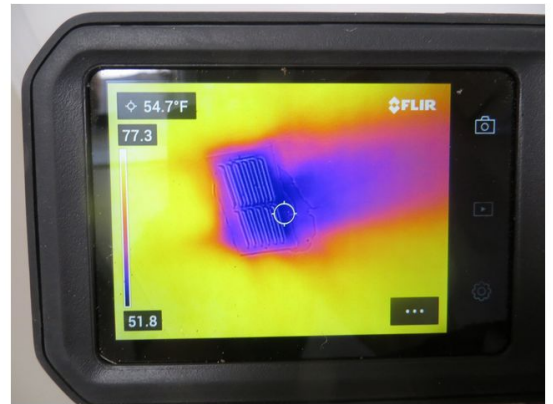
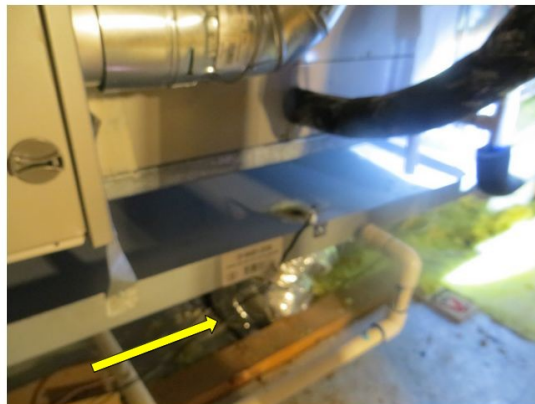
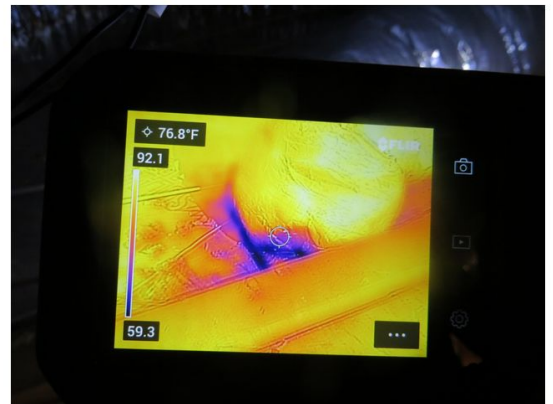
There is evidence of possible previous water intrusion in the ceiling in the upstairs rear corner bedroom. It is suspected that insulation around the ductwork boot should be improved to limits cold air from the AC mixing with the hot attic air. This condition should be further evaluated and corrected as necessary.

Fix of the upstairs balcony door and associated 1st story kitchen leak was fixed by "your home expert" on Nov 11, 2024 project manager Vitaly

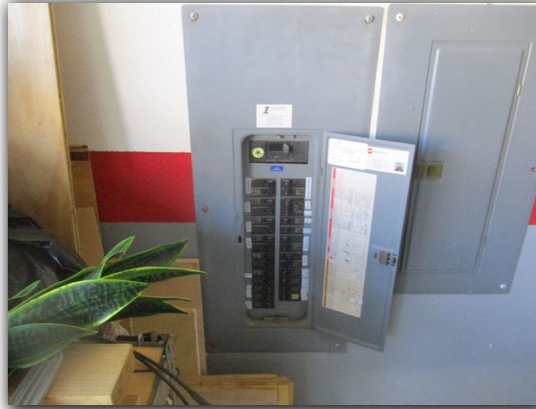
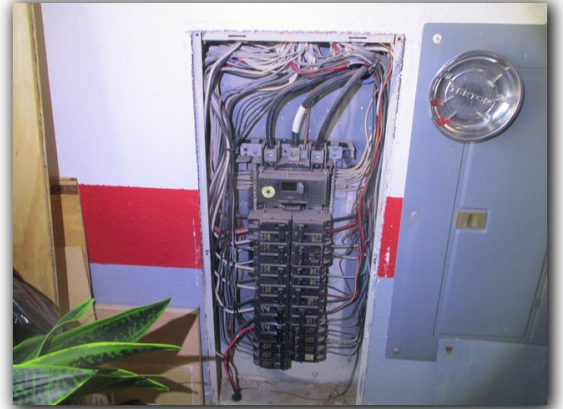
- The wires are entering the electrical cabinet through one bundle instead of multiple knockouts.
- One or more white wires is entering a breaker in the panel box where only black or red wires should be used. Recommend labeling these wires with black marker or black tape to distinguish them from being neutral wires.
- Neutral wires were observed to be "double lugged.". Each wire should have its own slot on the neutral bar. Not all main panels are rated to allow this condition. This condition should be further evaluated and corrected as necessary.
- One or more breakers were observed to be tripped or off upon our arrival to the inspection. With no notes left as to the reason for being in the off position, we will not attempt to turn it on for reasons of safety.
- There is debris observed in the panel box at the time of this inspection that should be cleaned and cleared.

Screws added and or replaced for plate cover. Area has been cleaned and cleared.

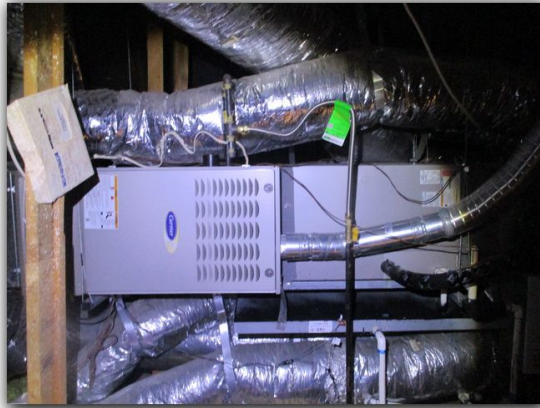
**Downstairs Central Heating System** – Energy Source: Gas  
Brand Name: Carrier

- The indoor blower was observed to be dirty and should be cleaned to help improve the efficiency of the unit.

**JOSE RUIZ**  
of A#1 Air preformed a tuneup / inspection of all three heaters on December 09, 2024. No issues were identified. A#1 was the regular servicer of the AC and heater units for the last 4 years.

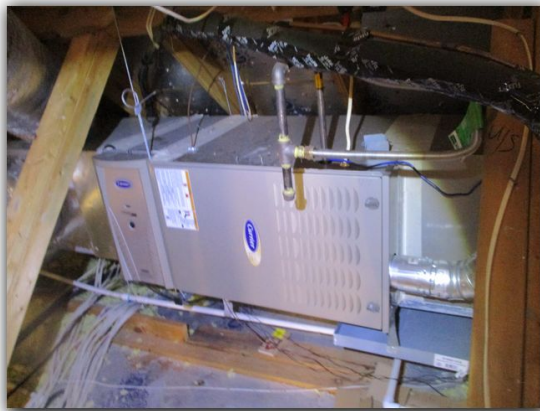
**Upstairs Central Heating System** – Energy Source: Gas  
Brand Name: Carrier

- The indoor blower was observed to be dirty and should be cleaned to help improve the efficiency of the unit.

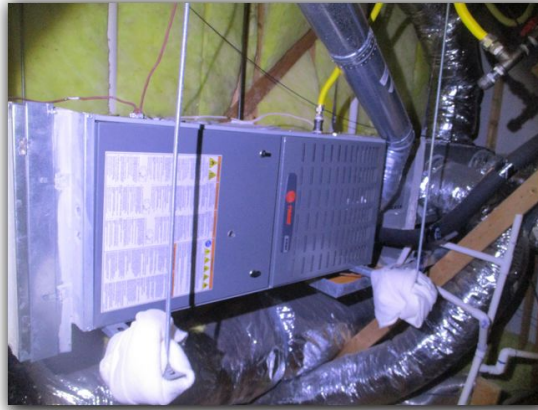
**Master Bedroom Central Heating System** – Energy Source: Gas  
Brand Name: Trane

- The indoor blower was observed to be dirty and should be cleaned to help improve the efficiency of the unit.

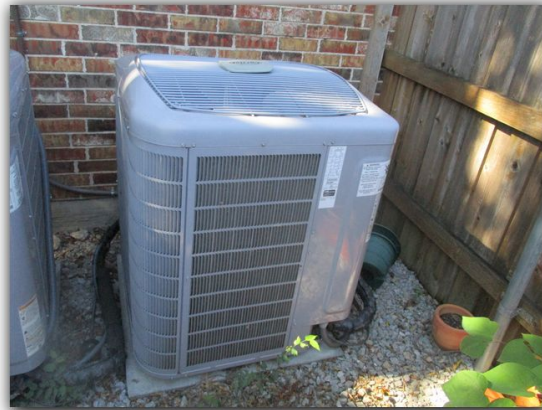
- The outdoor unit of the air conditioning system requires cleaning.
- The temperature drop measured across the area registers of the air conditioning system is lower than considered typical. This usually indicates that servicing is needed.

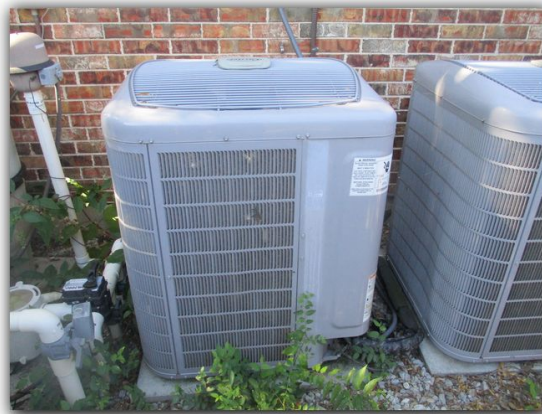
- The outdoor unit of the air conditioning system requires cleaning.

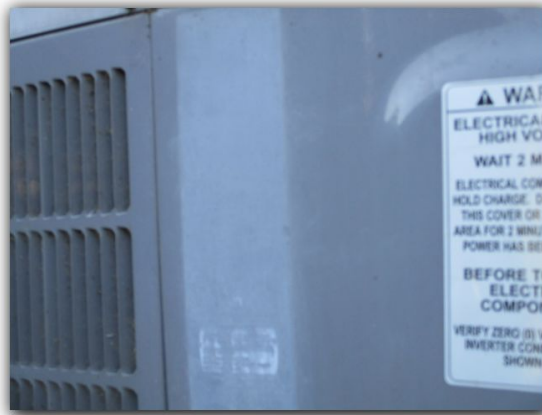
- **Note:** The manufacturer's label is damaged and/or missing. The inspector was unable to determine tonnage, SEER and/or age of the unit(s).

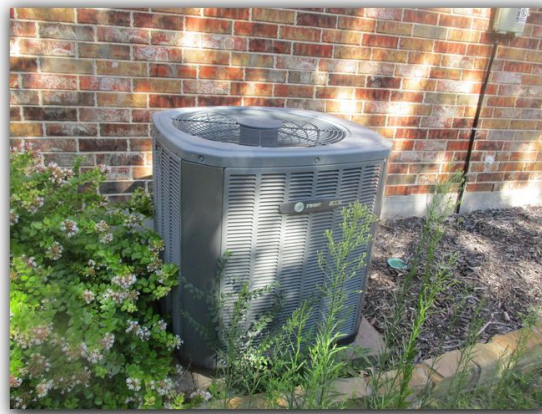
- The outdoor unit of the air conditioning system requires cleaning.
- The motor at the outside condenser shows signs of previous overheating and rust/corrosion.

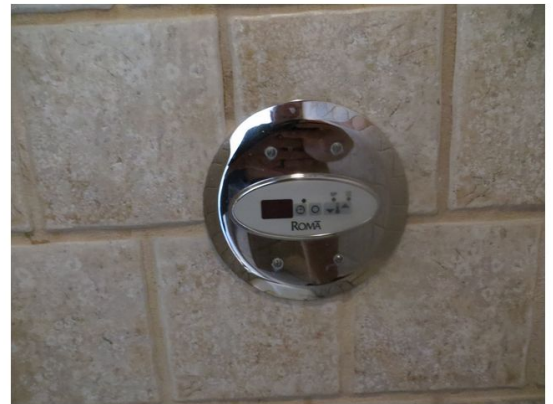
- The steamer in the shower area did have power but did not fully operate.

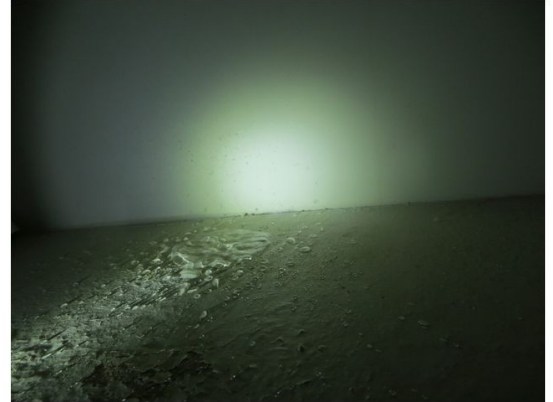
- The stopper does not appear to be functioning properly.
- The drain leaks water into the cabinet when drained under pressure with a large volume of water.

homeowner cleared obstructions and then cleaned with Drano

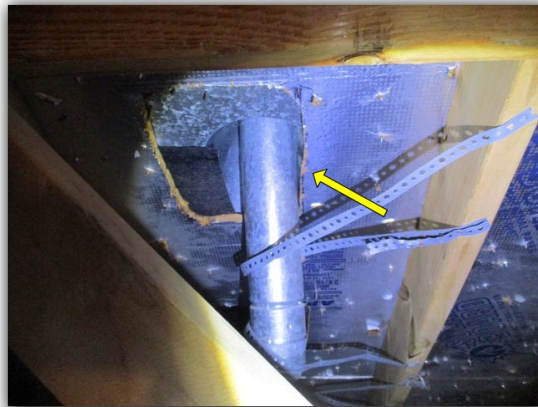
- The water heater flue (vent pipe) has inadequate clearance from combustibile materials. Double walled vent pipes should have at least 1-inch of clearance and single walled vent pipes should have at least 6-inches of clearance from combustibile material.

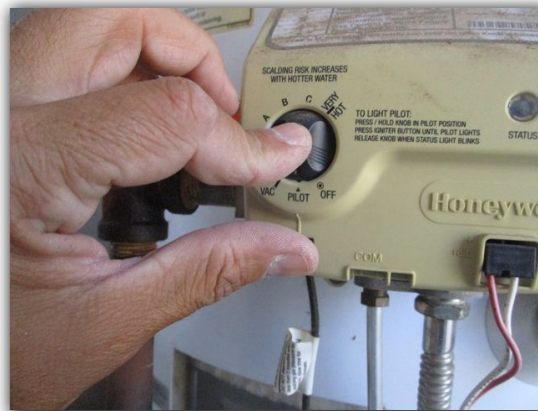
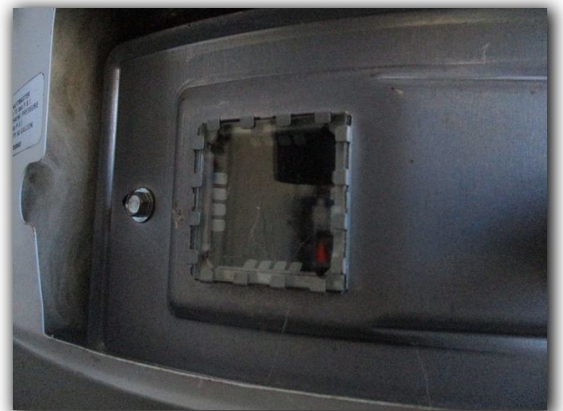
- The pilot light would not light after multiple attempts by the inspector. This condition should be further evaluated and corrected as necessary.

GTX plumbing tested and pilot light worked

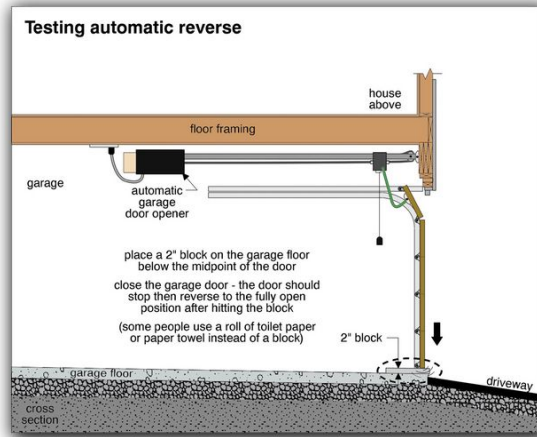
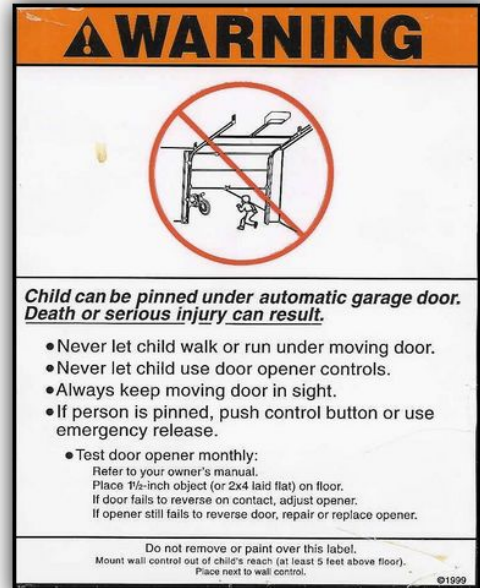
- When an automatic garage door opener is in use, the manual lock should be disabled or removed.
- The garage door opener **DID NOT** automatically reverse under reasonable resistance when closing. Improvement may be as simple as adjusting the sensitivity control on the opener.
