**GREEN SCENE**  
HOME INSPECTIONS  
*Do the Right Thing, Always tell the Truth, Help Others*

**23 Carter Ct, Allen, TX 75002**

Prepared For: Richard Lee Barrett, Sr. Living Trust, August 3, 2024

# PROPERTY INSPECTION REPORT FORM

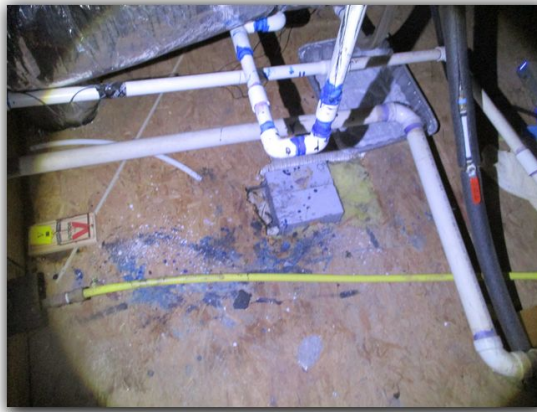
- **Note:** I was unable to inspect the attic completely due to the lack of decked space which impeded view and access.
- **Note:** Visible evidence of vermin and/or pest activity was observed in the attic area. It is recommended to have a Certified Pest Control Operator further evaluate this condition and make corrections as necessary.
- **Note:** The roofing system is designed in a way that one or more vulnerable areas exist. There is a higher potential for unanticipated repairs. Annual inspections and ongoing maintenance will be critical to the performance of the roofing system.

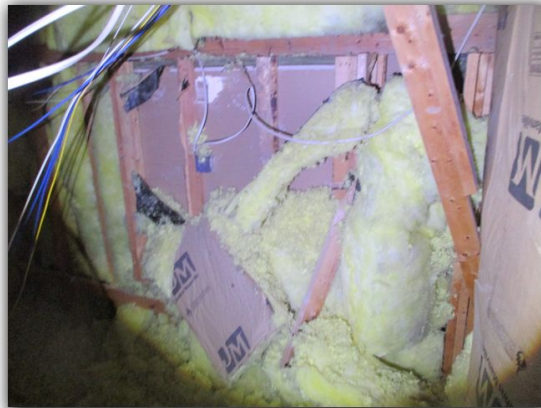
- **Note:** Recommend 6 to 10 inches of insulation be added to achieve an R-38 insulation depth to maximize your heating and cooling efficiency.

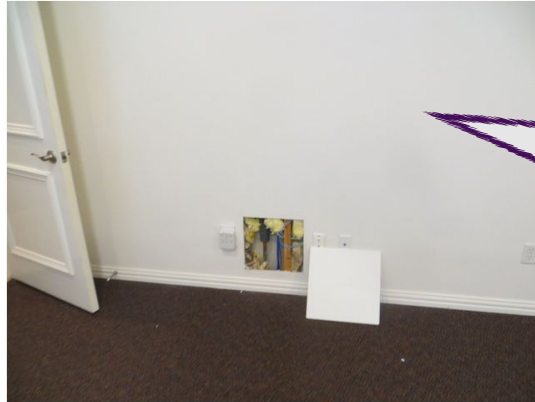
- Interior wall stress cracks were observed in the following areas, but not limited to: the upstairs guest bathroom closet.
- Interior wall joint cracks were observed in the: front entry area.

Dry wall repairs preformed by PREMIER PAINTING were preformed in 5 locations throughout the home fThese were created for computer network cable upgrades and expanding electrical in the bathroom for a bidet

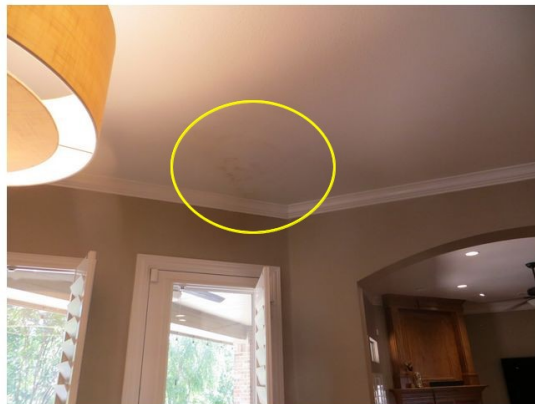
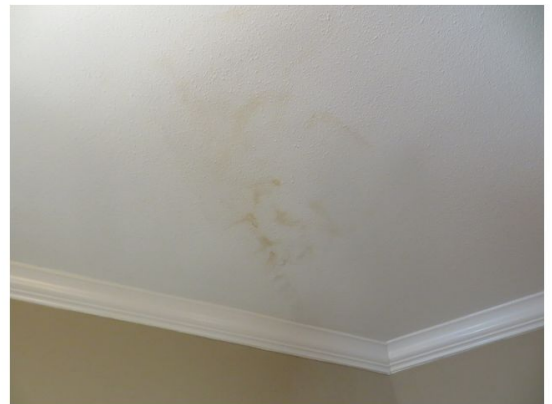
- Ceiling joint cracks were observed in the: garage. Possible previous water stains were observed on the ceiling in the: breakfast area, upstairs rear corner bedroom. Further investigation into the cause and remedy is recommended.

Fix of the upstairs balcony door and associated 1st story kitchen leak was fixed by "your home expert" on Nov 11, 2024 project manager Vitaly

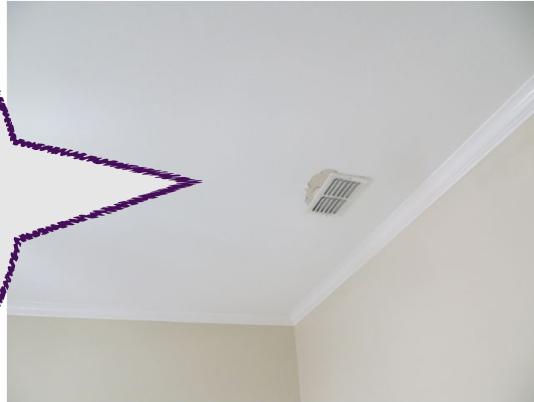
- Crown moulding separations were observed at the ceiling in the: living room. The cause and remedy should be further evaluated and corrected as necessary.

This was due insulation missing in the vent in the attic creating a temperature differential and associated condensation. This has been corrected and repaired by PREMIER PAINTING

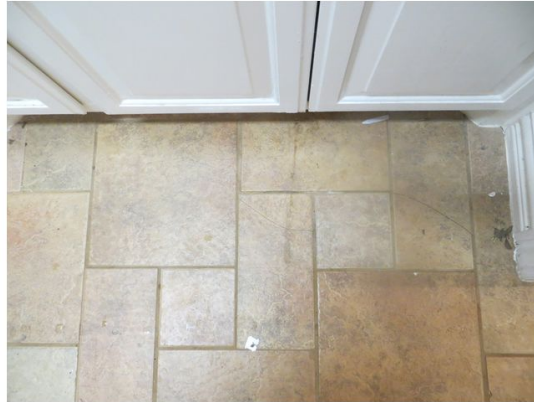
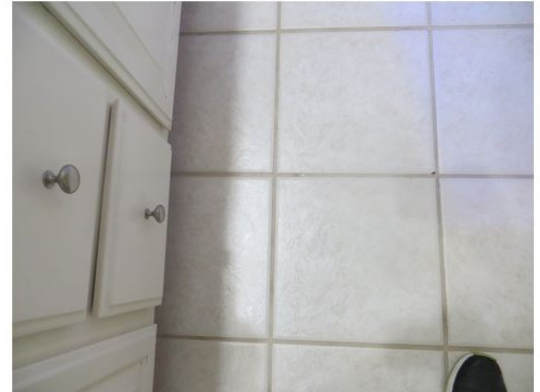
- **Note:** I was unable to inspect the flooring in various locations throughout the house completely due to personal effects and/or large, heavy or fragile storage at the time of this inspection which impede both view and access.
- **Note:** Some cracking of the garage concrete floor finish was observed.

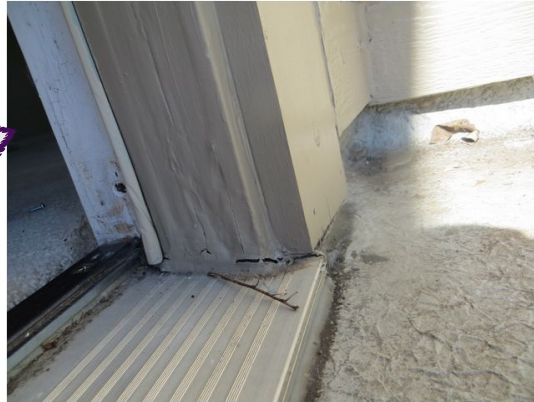
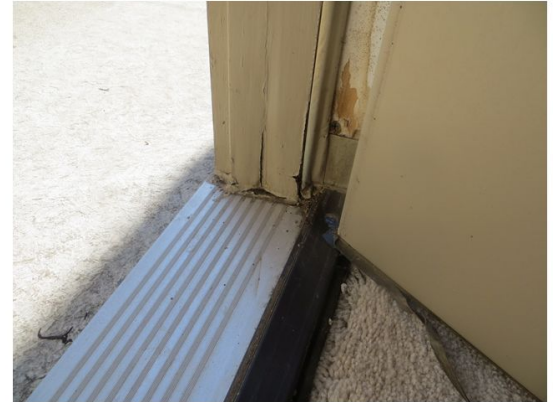
- The exterior doors were found to be aged and mostly functional. The exterior doors were found to show signs of rubbing, stiffness and/or difficulty operating, as well as degraded and general damage to the components. This is to be expected as part of the "wear-and-tear" of doors in a home of this age. Ongoing maintenance will need to be performed to assist the doors in their intended function. This will include but is not necessarily limited to: repair to the components, lubricating and weather stripping improvements, and regular adjustments and cleanings. The future life expectancy of the doors cannot be determined. You can continue to use and service these doors until replacement is necessary.
- The office door rubs when opened/closed.
- The front entry door hardware does not function properly.

Fix of the upstairs balcony door and associated 1st story kitchen leak was fixed by "your home expert" on Nov 11, 2024 project manager Vitaly

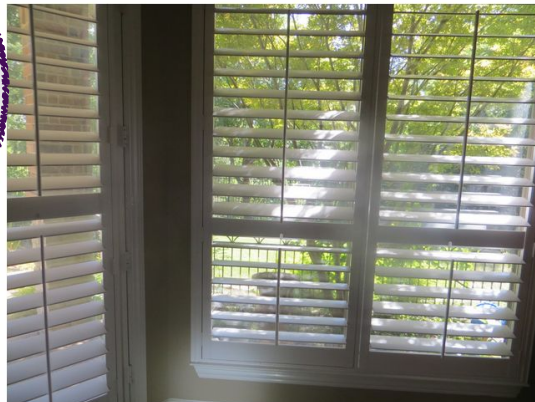
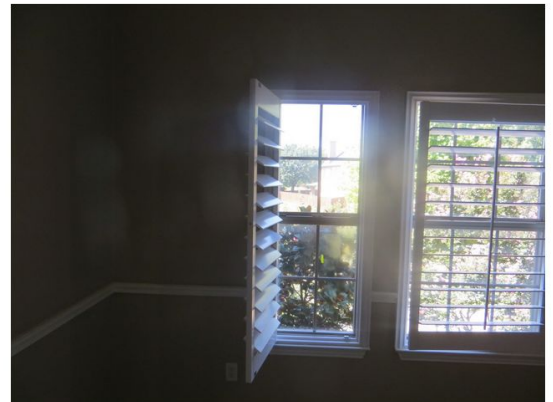
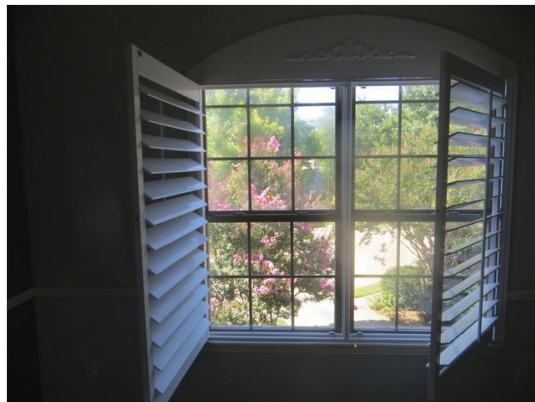
- One or more of the thermal pane windows were observed to have lost their seals. This has resulted in condensation or a fog like film to develop between the panes of glass. The thermal pane windows no longer function as designed when they lose their seal and replacement may be necessary. The windows that have noticeably lost their seals are listed but may not be limited to the following: master bedroom, upstairs front middle bedroom, upstairs front corner bedroom.

PRECISION WINDOWS on Nov 17th and 27th replaced glass in a total of 13 windows on any identified as having a seal issue.

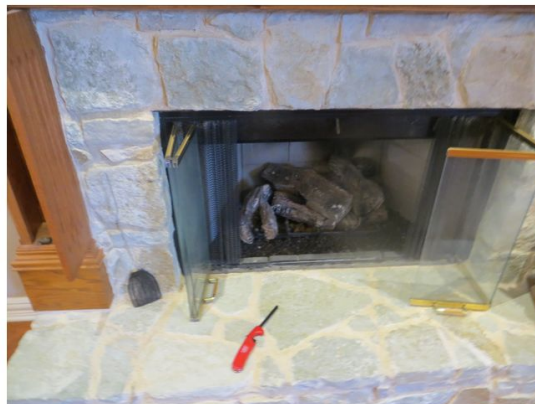
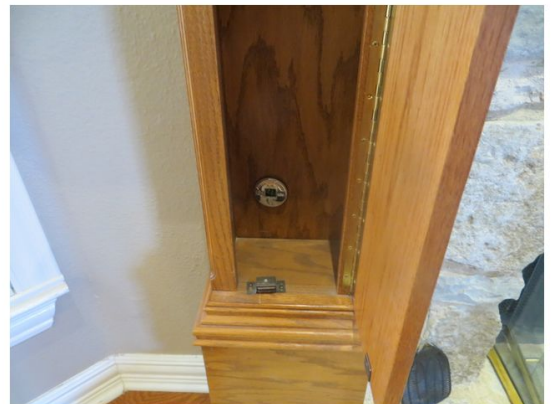
- The fireplace would not come on at the time of this inspection when the switch was engaged.

October 13th, 2024  
 Ace Fireplace services  
 inspected and reset  
 fireplace controllers. They  
 are all functional and  
 safe to use.

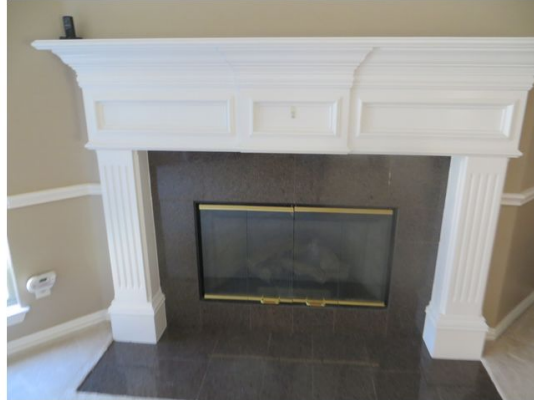
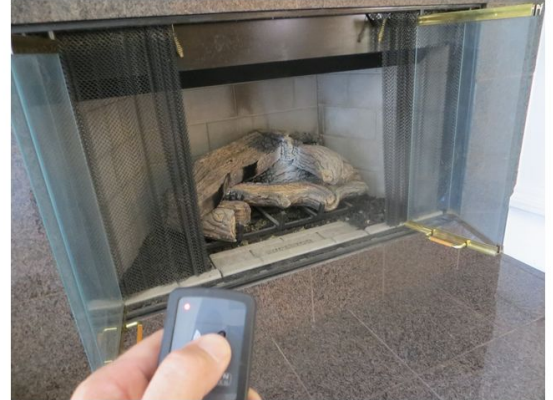
- The fireplace would not come on at the time of this inspection when the remote was engaged.

October 13th, 2024  
Ace Fireplace services  
inspected and reset  
fireplace controllers. They  
are all functional and  
safe to use.

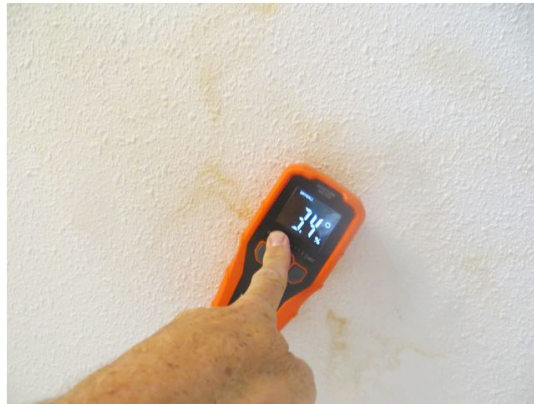
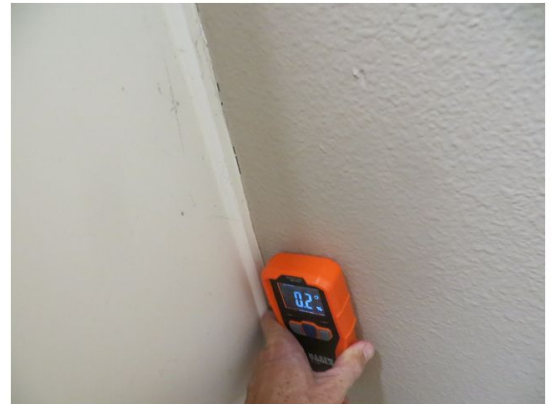
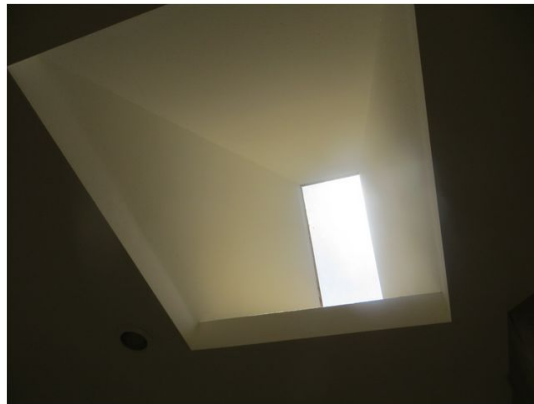
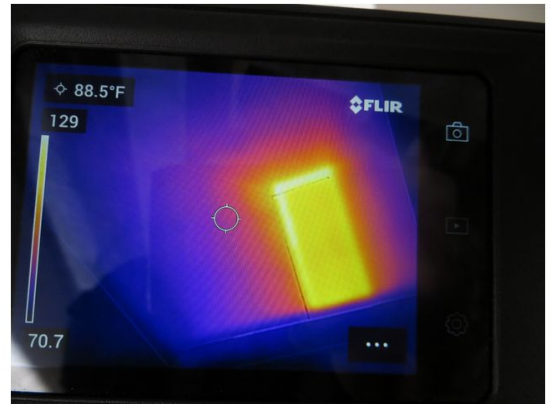
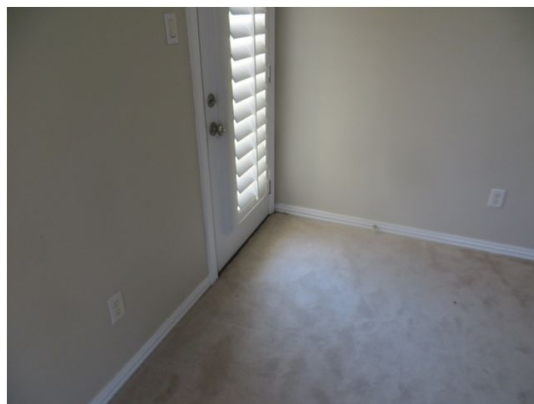
- There is evidence of possible previous water intrusion in one or more of the floors in the upstairs rear corner bedroom. Although all moisture content was within an acceptable level, this condition should be further evaluated and corrected as necessary.

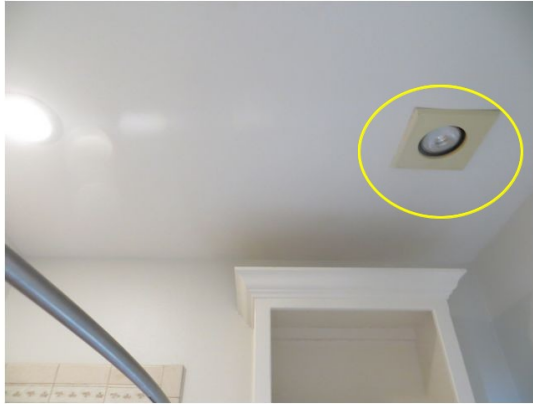
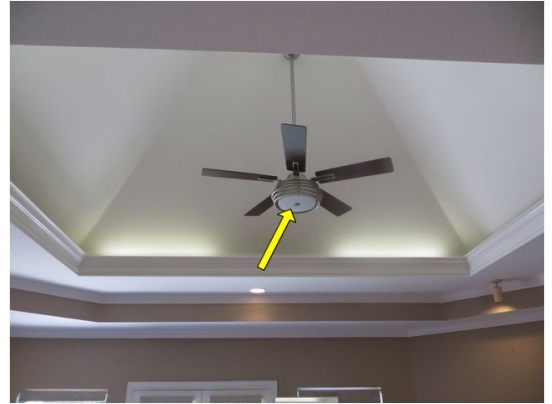
- Exterior light fixtures should be sealed at the base to prevent water intrusion behind the wall.
- One or more of the light fixtures appear to be inoperative in the: Jack and Jill bathroom, upstairs living room. This may be due to a bad bulb or some other unknown condition. This condition should be further evaluated and corrected as necessary.

Previous resident had unscrewed the bulbs. These fixtures were working. However, out of energy efficiency many of the bulbs were upgraded to led lights.

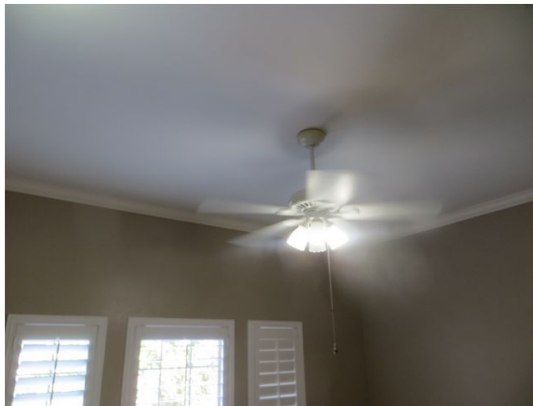
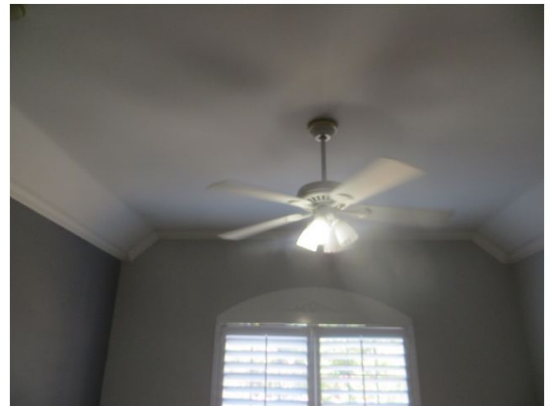
- The ceiling fan is not balanced properly and wobbles when operated in the: upstairs front middle bedroom, upstairs front corner bedroom.

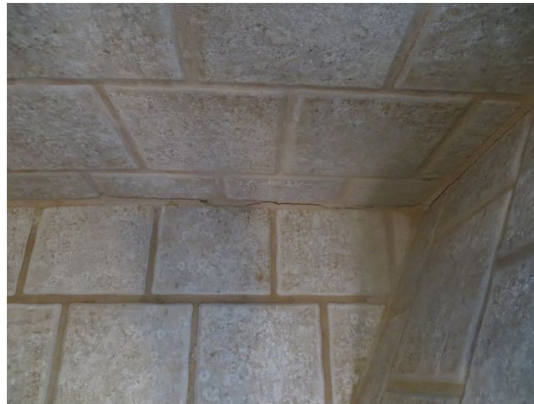
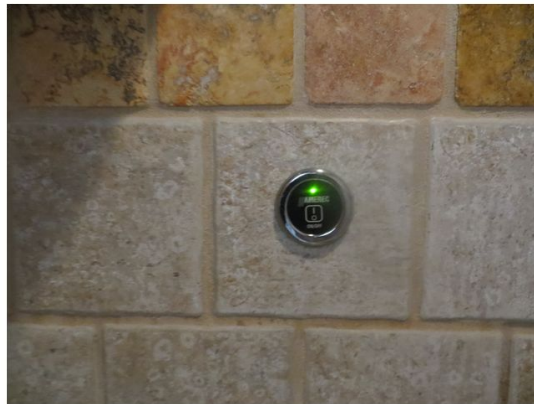
Steam shower takes time to start and is operational however as noted the timer control did not come on.

- The steamer in the shower area did have power but did not fully operate.

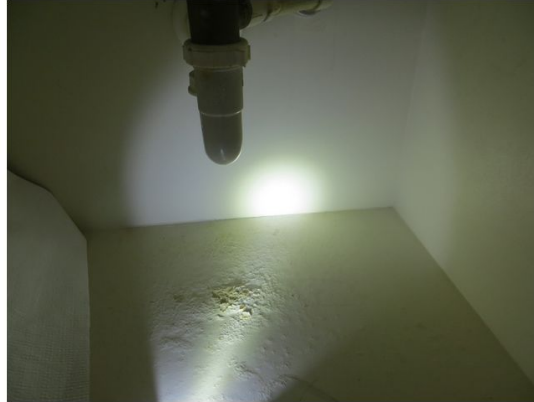
- The stopper does not appear to be functioning properly.
- The drain leaks water into the cabinet when drained under pressure with a large volume of water.

homeowner cleared obstructions and then cleaned with Drano

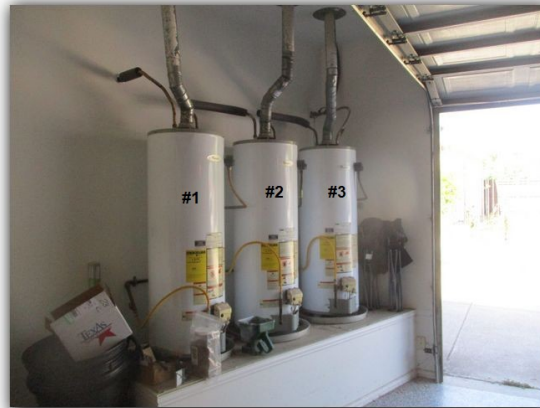
- The fittings at the top of the water heater are made of dissimilar metals (galvanized steel connected to copper and/or brass). It is recommended to replace the galvanized steel fittings with brass or copper fittings or install a dielectric union between the two dissimilar metals to prevent electrolysis from occurring.
- Some corrosion was observed at the water supply connections at the top of the water heater.

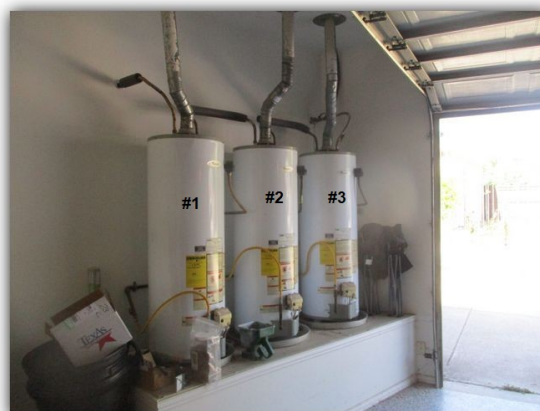
- The water heater flue (vent pipe) has inadequate clearance from combustibile materials. Double walled vent pipes should have at least 1-inch of clearance and single walled vent pipes should have at least 6-inches of clearance from combustibile material.

- The fittings at the top of the water heater are made of dissimilar metals (galvanized steel connected to copper and/or brass). It is recommended to replace the galvanized steel fittings with brass or copper fittings or install a dielectric union between the two dissimilar metals to prevent electrolysis from occurring.
- Some corrosion was observed at the water supply connections at the top of the water heater.

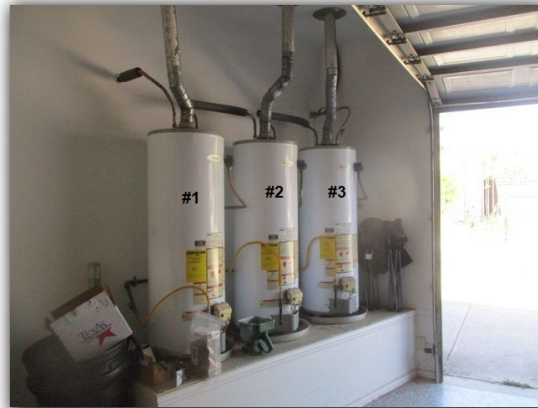
- The pilot light would not light after multiple attempts by the inspector. This condition should be further evaluated and corrected as necessary.

GTX plumbing tested and pilot light worked
